Manhole Inspection Summary

Manhole # S41K__020MH

Insp Date: **10/30/08 3:07 PM**

Location Address: **509 s eden st**

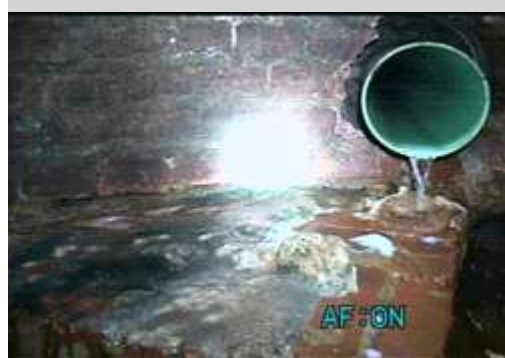
Defect 3

Condition: ☐ Sound ☐ Cracked ☐ Root Intrusion ☐ Deteriorated ☐ Leaks ☒ **Debris**

bench debris

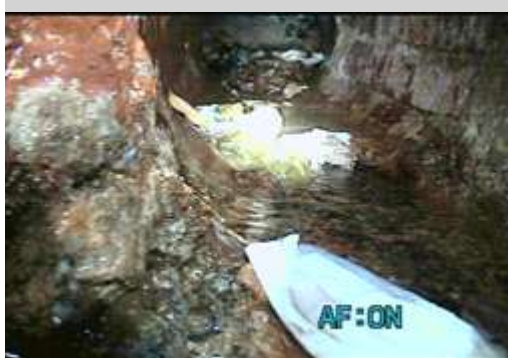
Defect 2

Condition: ☐ Sound ☐ Cracked ☐ Root Intrusion ☐ Deteriorated ☒ **Leaks** ☒ **Debris**

channel debris

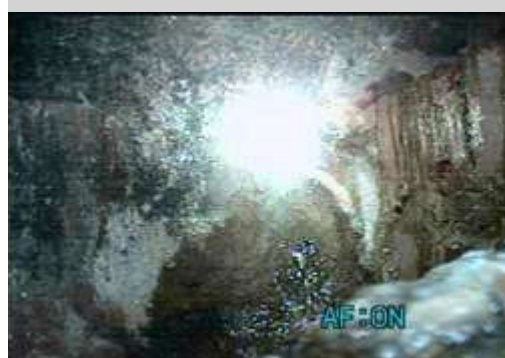
Defect

infiltration in channel

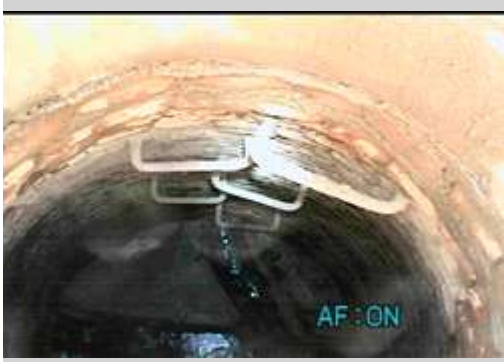
Defect 1

Condition: ☐ Sound ☒ **Cracked** ☐ Root Intrusion ☐ Loose Brick ☐ Deteriorated

Count: **5** Missing: **0** ☒ **Corroded**

corroded steps, cracked corbel

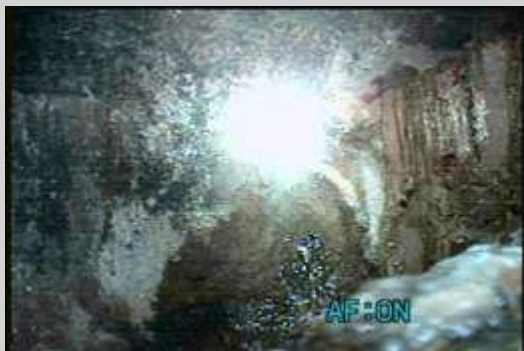
3 O'Clock Inflow

infiltration where pipe 3 was sealed up

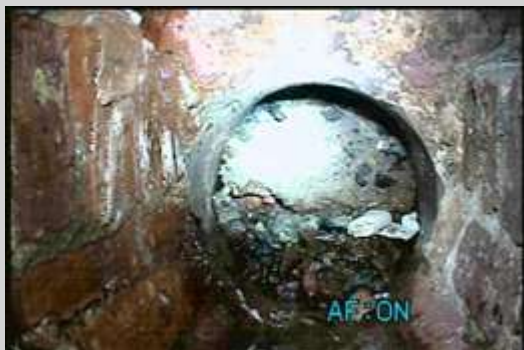
6 O'Clock Inflow

Deposits: ☐ None ☒ **Mud** ☐ Sludge ☒ **Debris** ☐ Grease
